#### 2007.09.13 - Reference Job - "Os Aveirenses" (Backery Shop) - Aveiro

#### 2007.09.13 – Reference Job "ACM" – Lisbon (Parque das Nações)

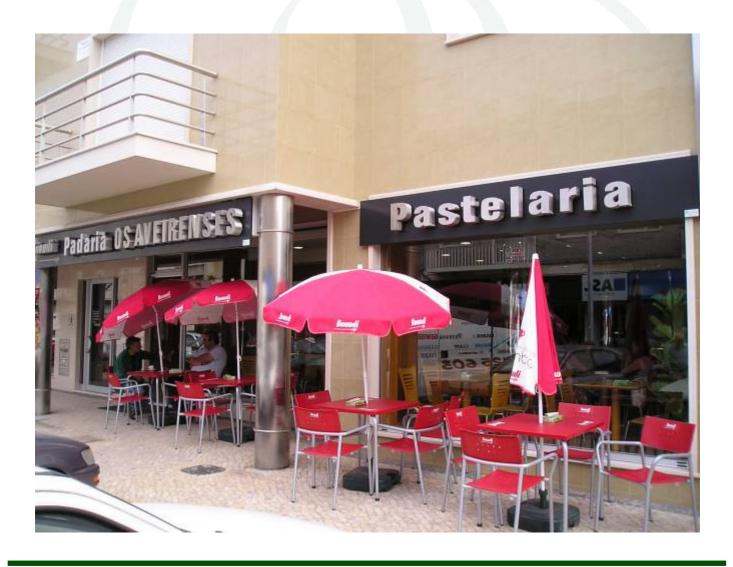
- Installed AcoustiCORK T61 under Ceramic Tiles in the Customers Seating Area (around 200m^2).
- Installed 5015 5mm (less compressible and more load resistance than T61) under Ceramic Tiles in the; Toilet and Backery Production Area, due to Machine Load.

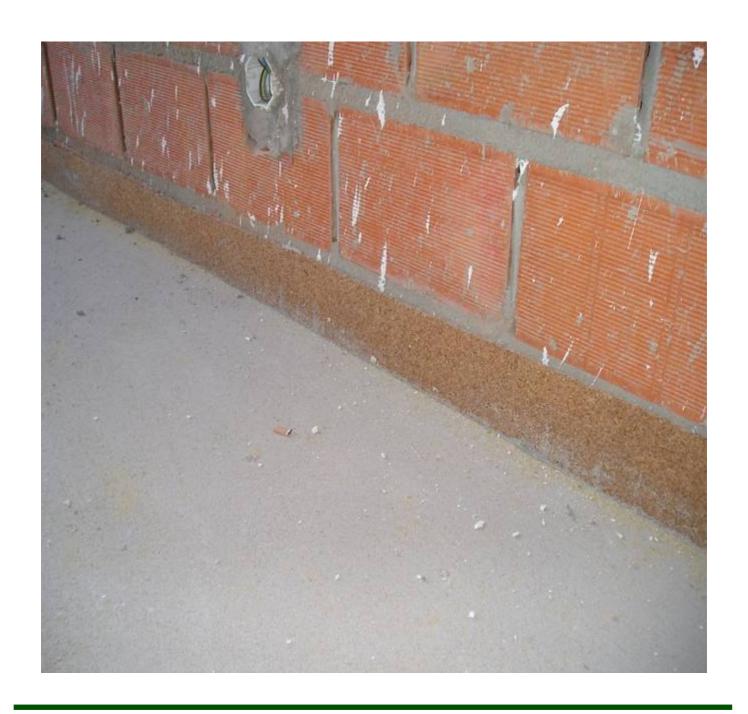
#### Perimeter Insulation Barrier

- Installed AcoustiCORK T61 under Concrete Floating Slab (no steel reinforced) in a 26 Floor Residential Building.
- The assembly of the Slab:
  - i) 18 cm pumped concrete
  - ii) 8 cm pumped poor concrete
  - iii) AcoustiCORK T61
  - iv) 6 cm pumped poor concrete
  - v) final floor
- All the pipes were worked in the iv) layer.
- The perimet insulation barrier was installed (please see photo).
- Business Oportunity:
  - i) In the brick wall, each 10m (vertically) was installed a 5mm rubber joint (from CDM).
  - ii) Our 5019 could answer easly this application.
